Wildlife Lake Habitat Survey Report

NAME OF LAKE: Freeborn

DATE OF SURVEY: 8/9/2012

TYPE OF SURVEY: Wildlife Lake Survey

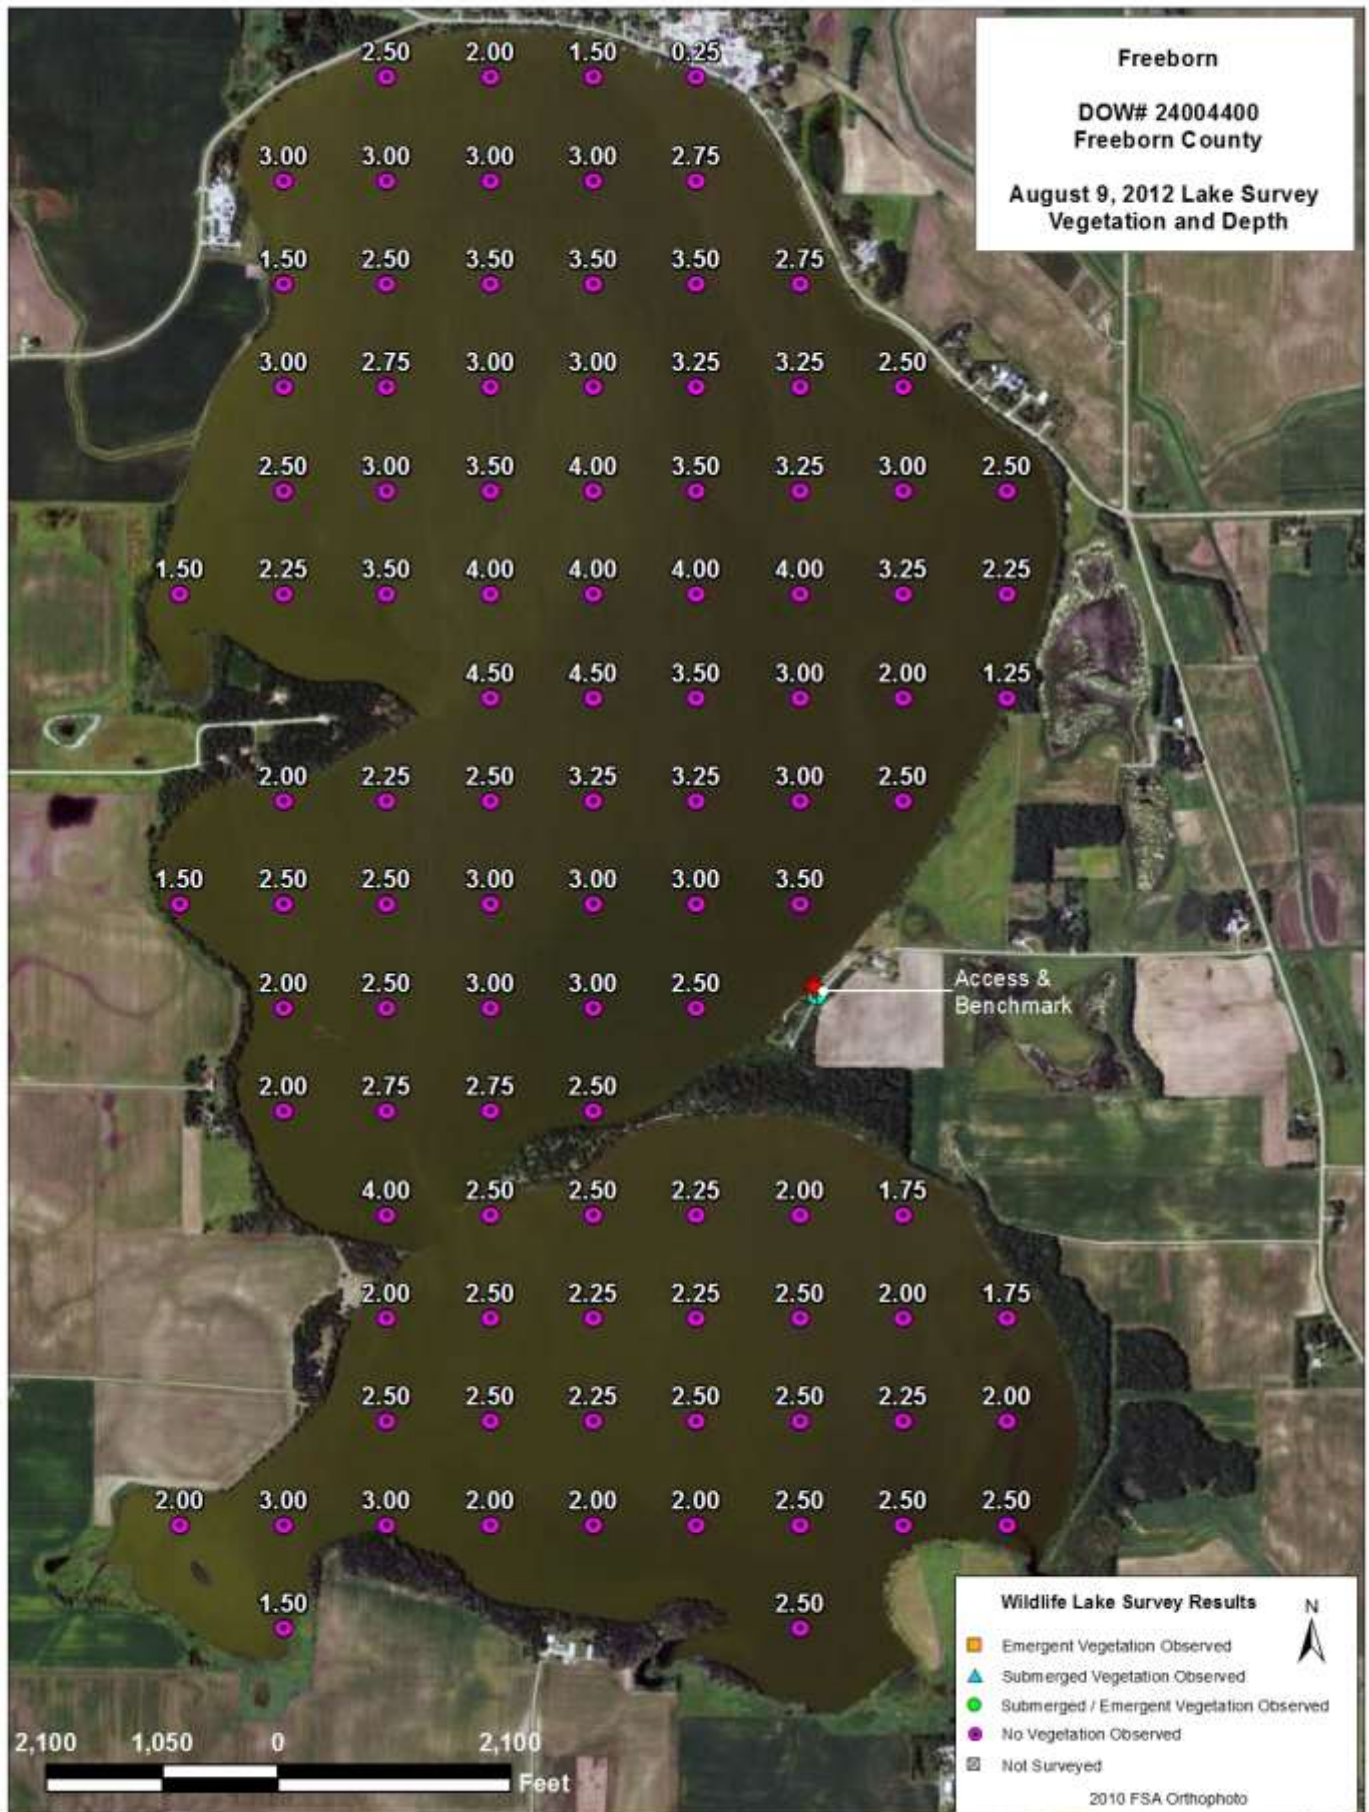
Survey Map

Minimum Depth: 0.25 Minimum Secchi: 0.25 Initial # of Stations: 99
Maximum Depth: 4.50 Maximum Secchi: 0.25 Number of Stations Sampled: 99
Mean Depth: 2.67 Mean Secchi: 0.25
